CERTIFICATE OF APPROPRIATENESS

Property: 600 Avondale Street, Lot 5, Tract 4, Block 6, Montrose Subdivision. The property includes a historic two-story brick and wood frame single-family residence and a detached garage apartment situated on a 9,750 square foot (75' x 130') interior lot.

Proposal: Alteration – Windows

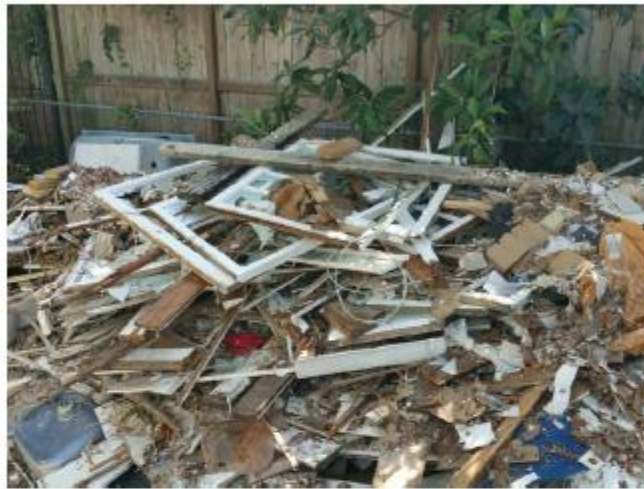
Figure 3 Rotten windows, broken glass that was needed to be taken out

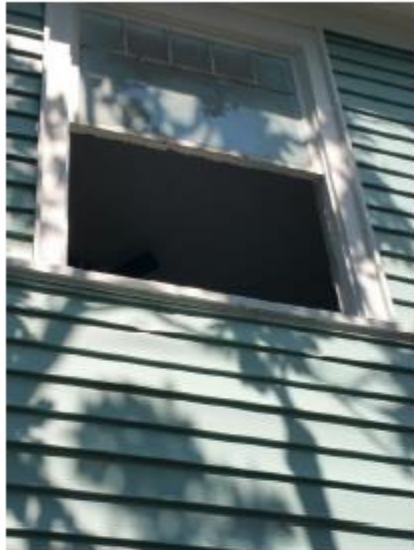
Figure 5 window will remain and to be repair to its original condition and to keep its integrity

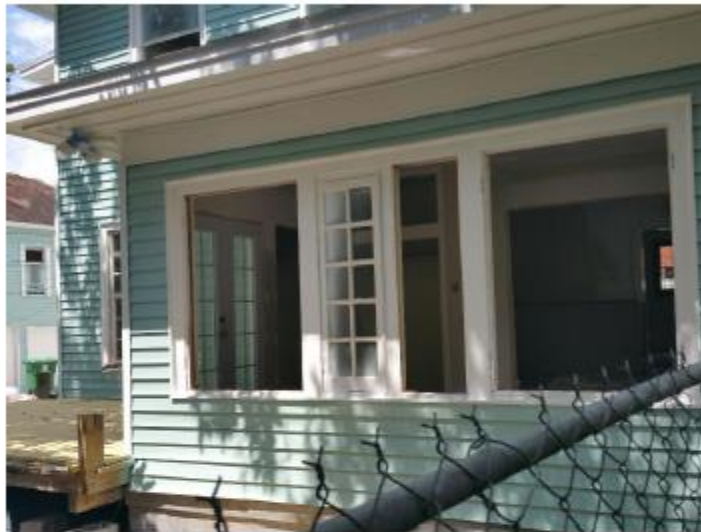
Figure 10 WE WILL RESTORE EXISTING WINDOW AND KEEP ORIGINAL INTEGRITY; GC WILL SALVAGE WINDOW FROM THE PILE OF TRASH AND REPAIR TO ITS ORIGINAL LOOKS.

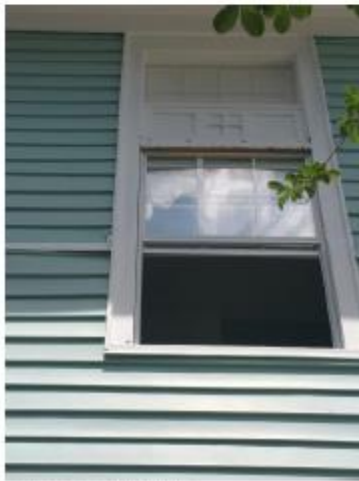
lower sash will be

Figure 11 existing window top sash to remain and we will repair the

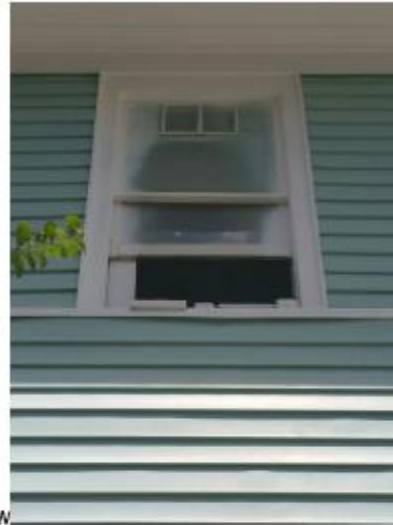
replacing with new wood window

Figure 12 window will be remaining and be repair

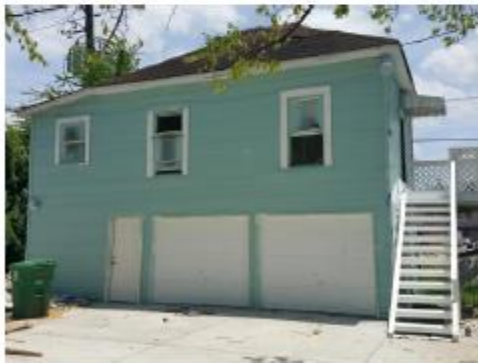
Figure 13 Replace doors and windows – windows to be replace with vinyl cladding
